WORK PLAN

FOR WATERSHED PROTECTION AND FLOOD PREVENTION

NORTHEAST TRIBUTARIES OF THE LEON RIVER WATERSHED Cow-Armstrong and Resley Creeks Comanche, Erath, and Eastland Counties, Texas

March 1961

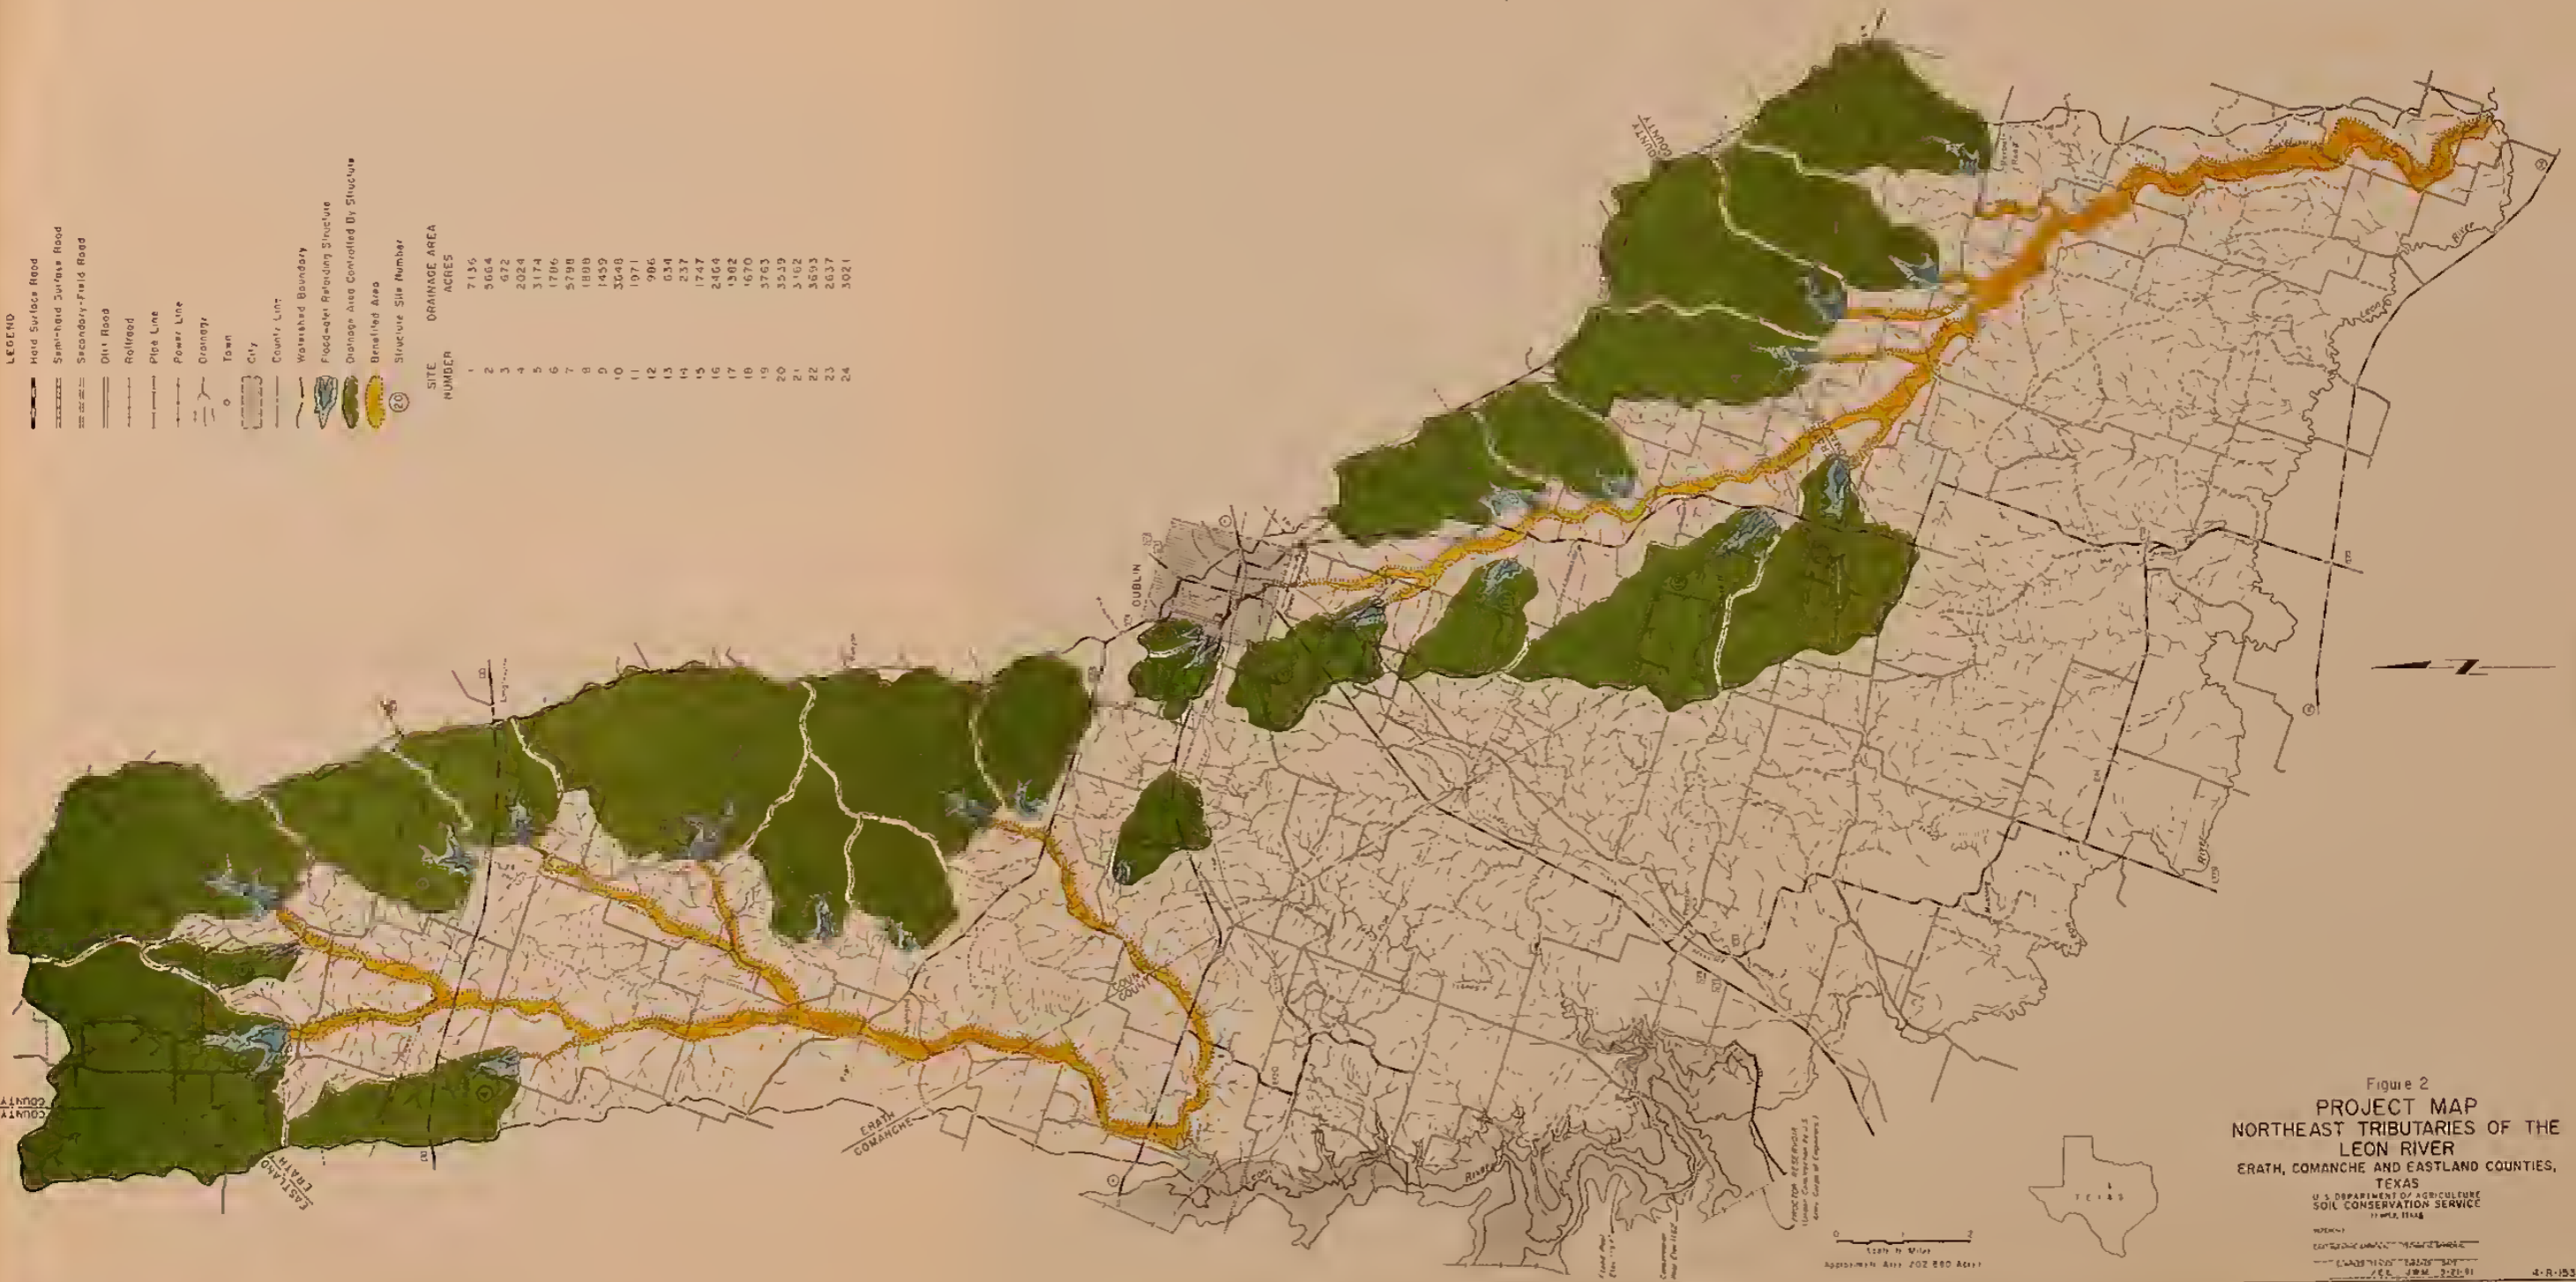
Figure 2
PROJECT MAP
NORTHEAST TRIBUTARIES OF THE
LEON RIVER
ERATH, COMANCHE AND EASTLAND COUNTIES,
TEXAS
U.S. DEPARTMENT OF AGRICULTURE
SOIL CONSERVATION SERVICE
11 APR. 1948
Scale 4-R-15351
Base 4-R-13848

SITE NUMBER	DRAINAGE AREA ACRES
1	7136
2	9664
3	672
4	2024
5	3174
6	1706
7	5798
8	1898
9	1459
10	3048
11	1971
12	906
13	634
14	237
15	1747
16	2464
17	1302
18	1670
19	3763
20	3539
21	5162
22	3693
23	2637
24	3021

4. Only public road adverse situations caused by installation of the project have been shown on the Project Map (Figure 2). Other similar situations may exist on private ownerships the entire length of the stream channels. The sponsoring local organizations have been advised of this condition and an allowance has been made for them in determining the feasibility of the project. Action to be taken for the protection of the sponsors' interest is for the determination of and the responsibility of the cosponsors.

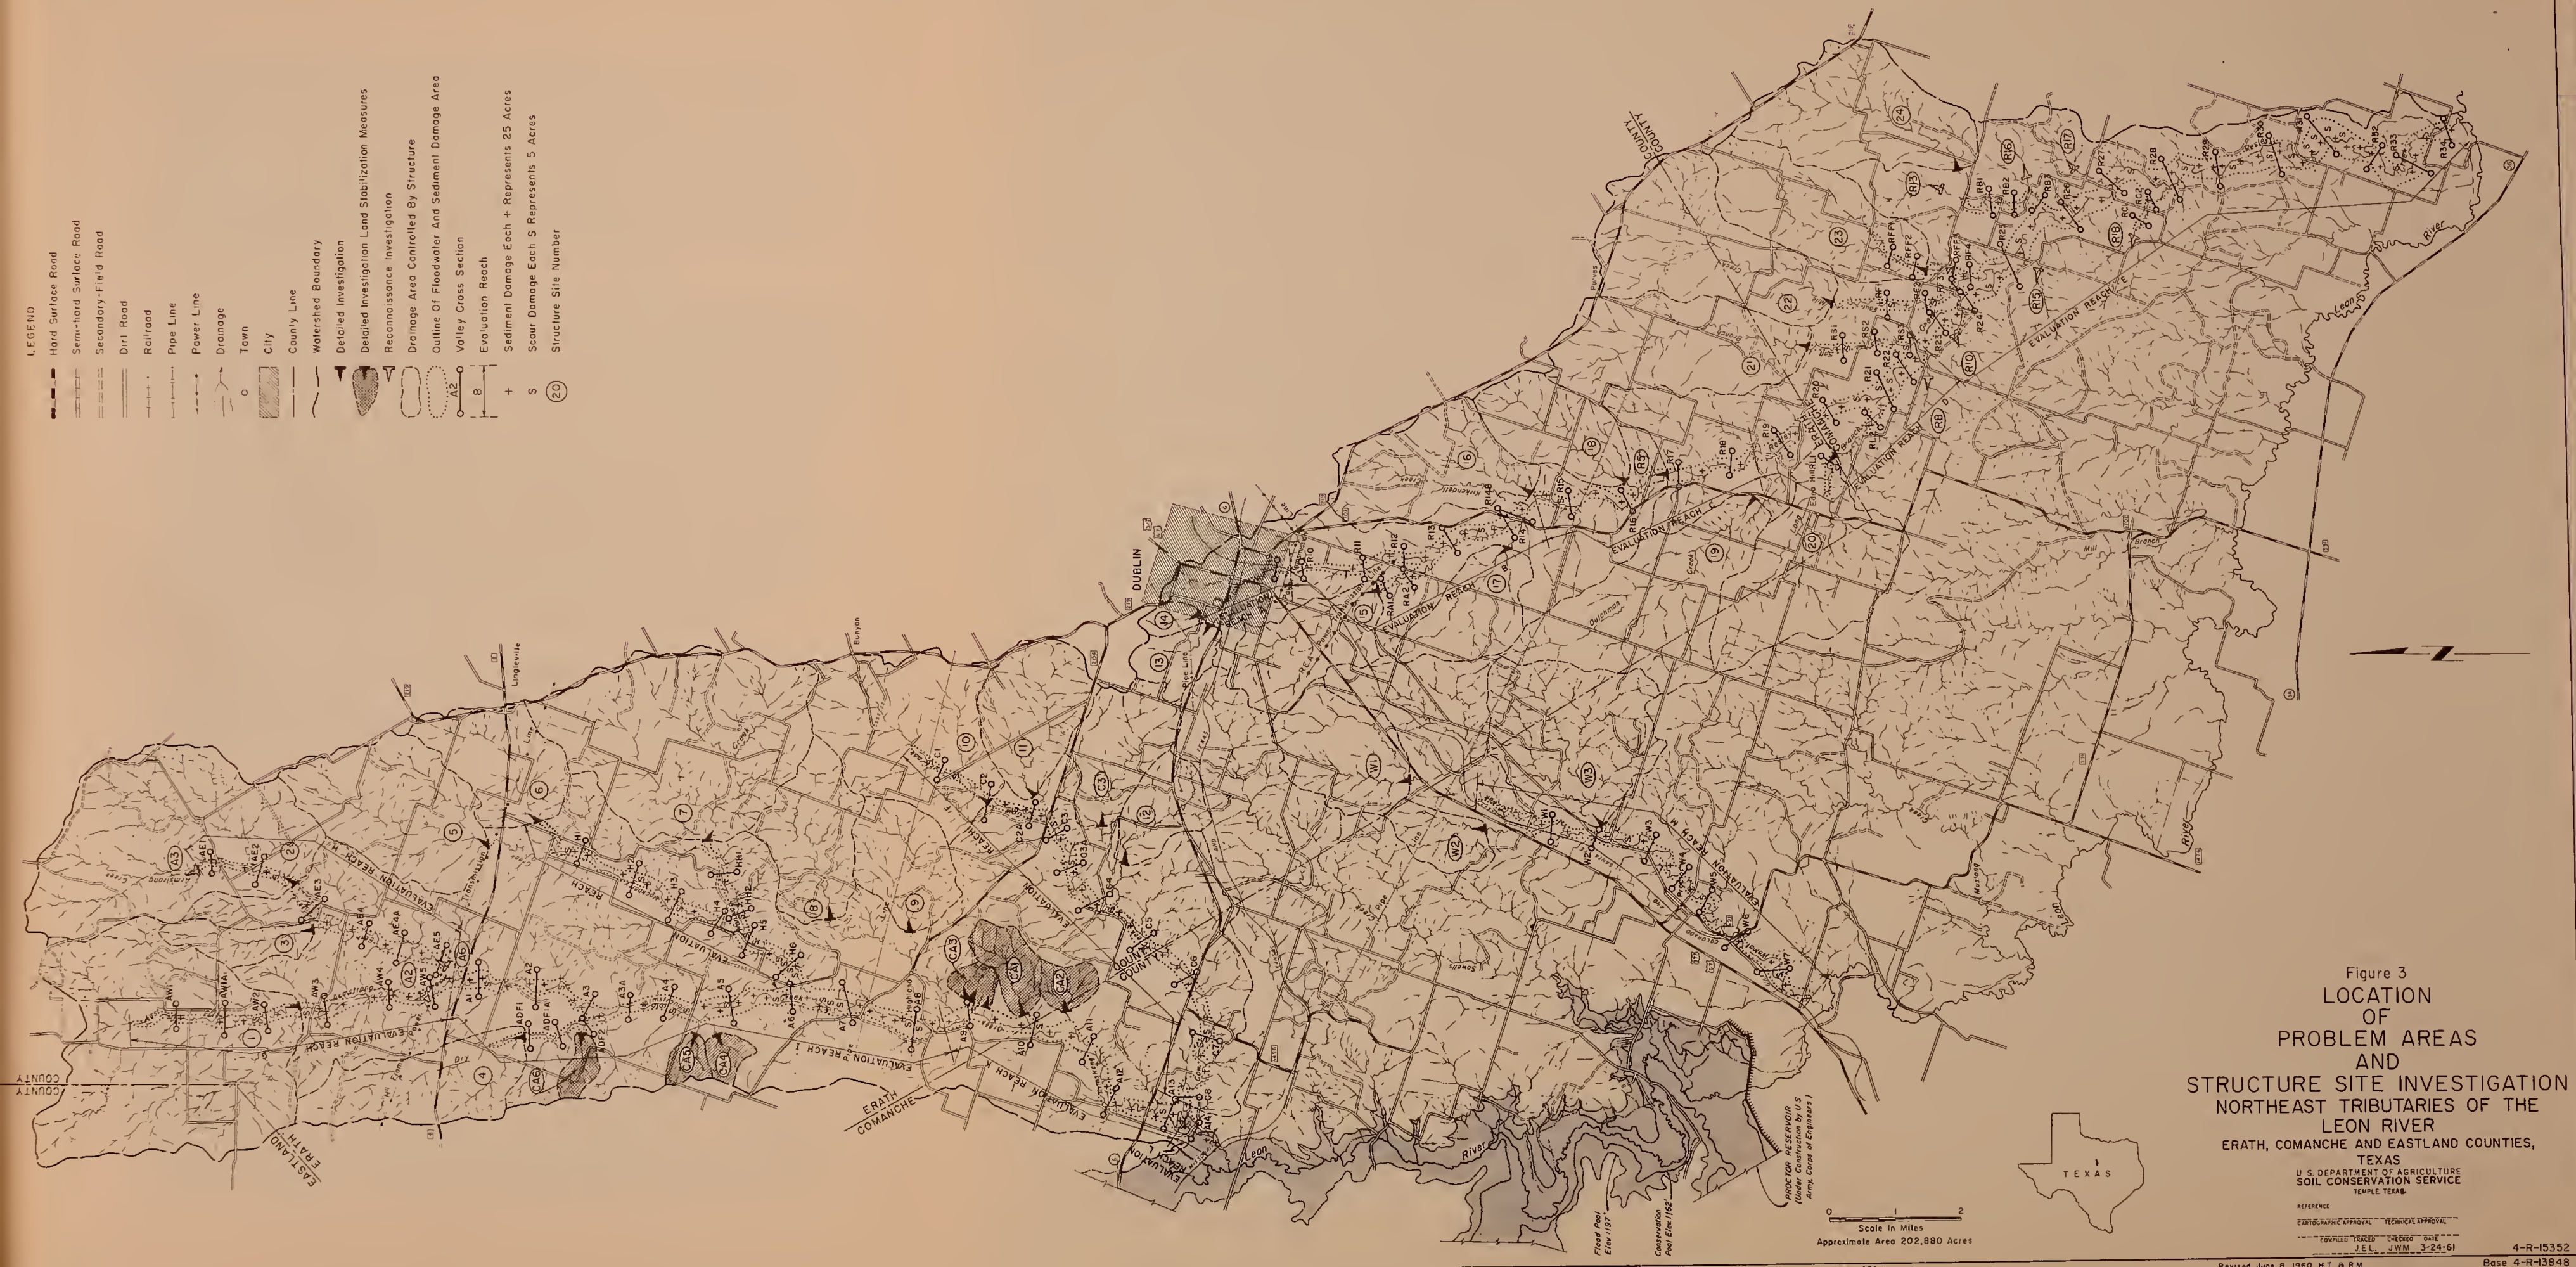
8. Data obtained in land treatment needs studies for the watershed, as well as hydraulic, hydrologic, geologic, sedimentation, and economic investigations provided the necessary means for evaluating various combinations and locations of floodwater retarding structures. As a result of this analysis it was determined that 24 floodwater retarding structures would be the most economical system to install that would provide a level of protection acceptable by the cosponsoring organizations although their original objectives were not met on Walnut Creek. Detailed studies on Walnut Creek indicated that the cost of installing structural measures for flood prevention exceeded the benefits that could be derived therefrom; therefore a favorable benefit-cost ratio could not be obtained in this reach. Plans of a floodwater retarding structure, typical of those planned for the watershed, are illustrated by figures 4 and 4A.

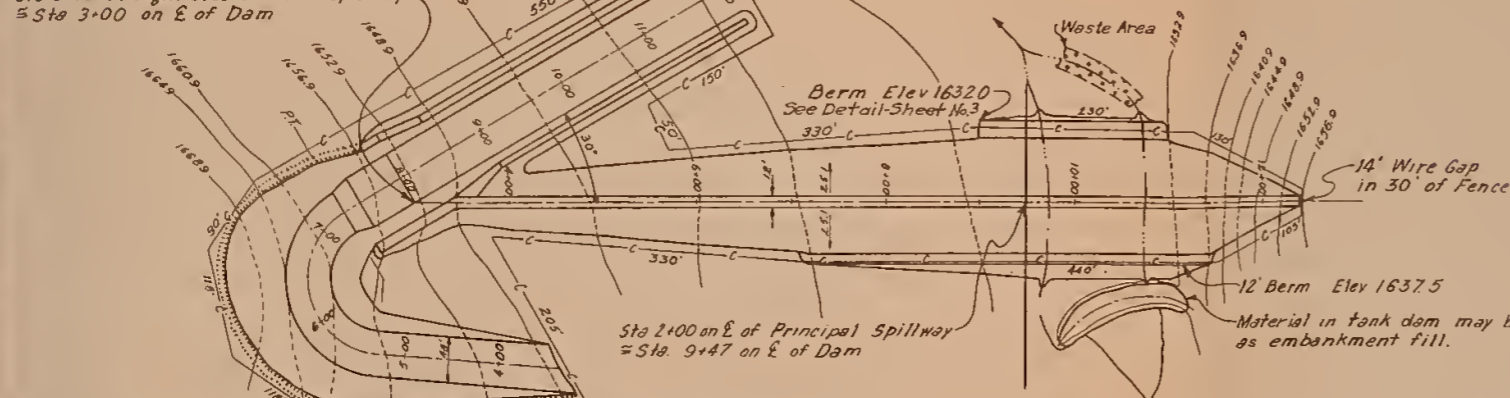
EMERGENCY SPILLWAY CURVE DATA

$\Delta = 144^{\circ}00'$
 $D = 71^{\circ}37'$
 $R = 80.35'$
 $L = 201.0'$
 $P.C. = Sta. 5+29$
 $P.T. = Sta. 7+30$
